Subject: 2008 Inspection Cycle.

INITIAL ASSESSMENT FORM FOR STRUCTURE :

L41602009+00001

Location : 9M NE DARBY Structure Name: none

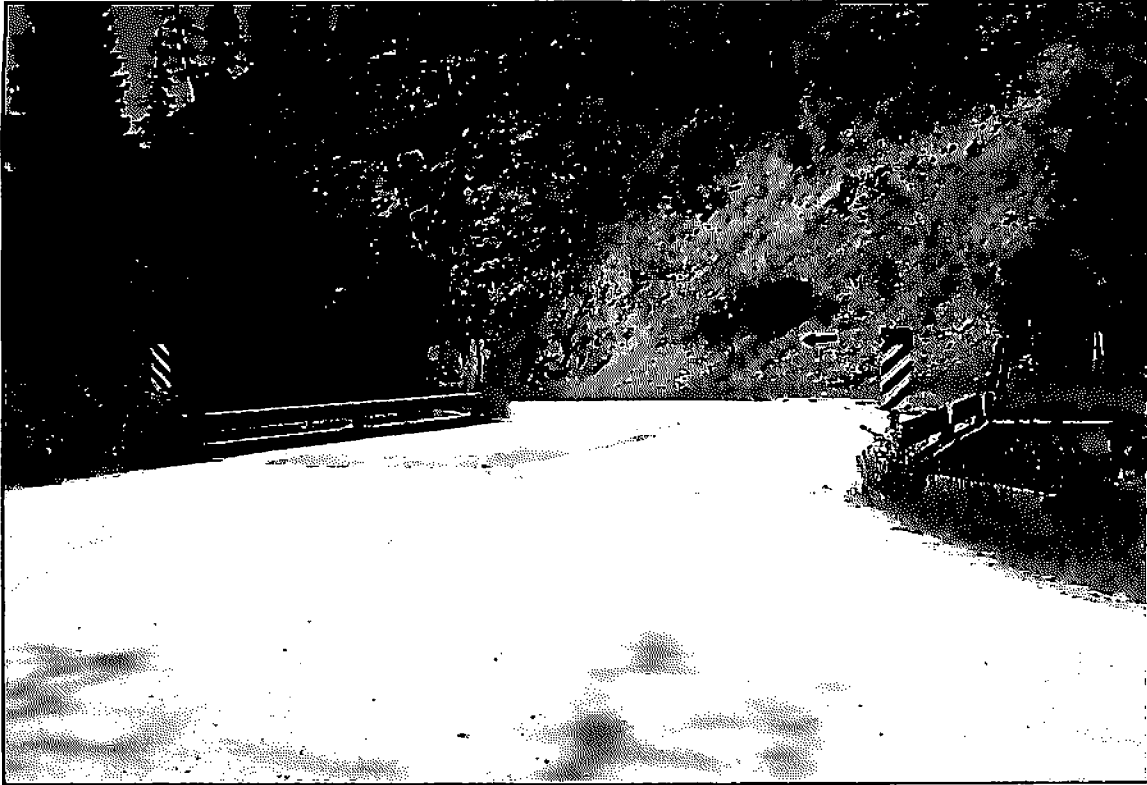
Looking Back on Line. Downstream. ←

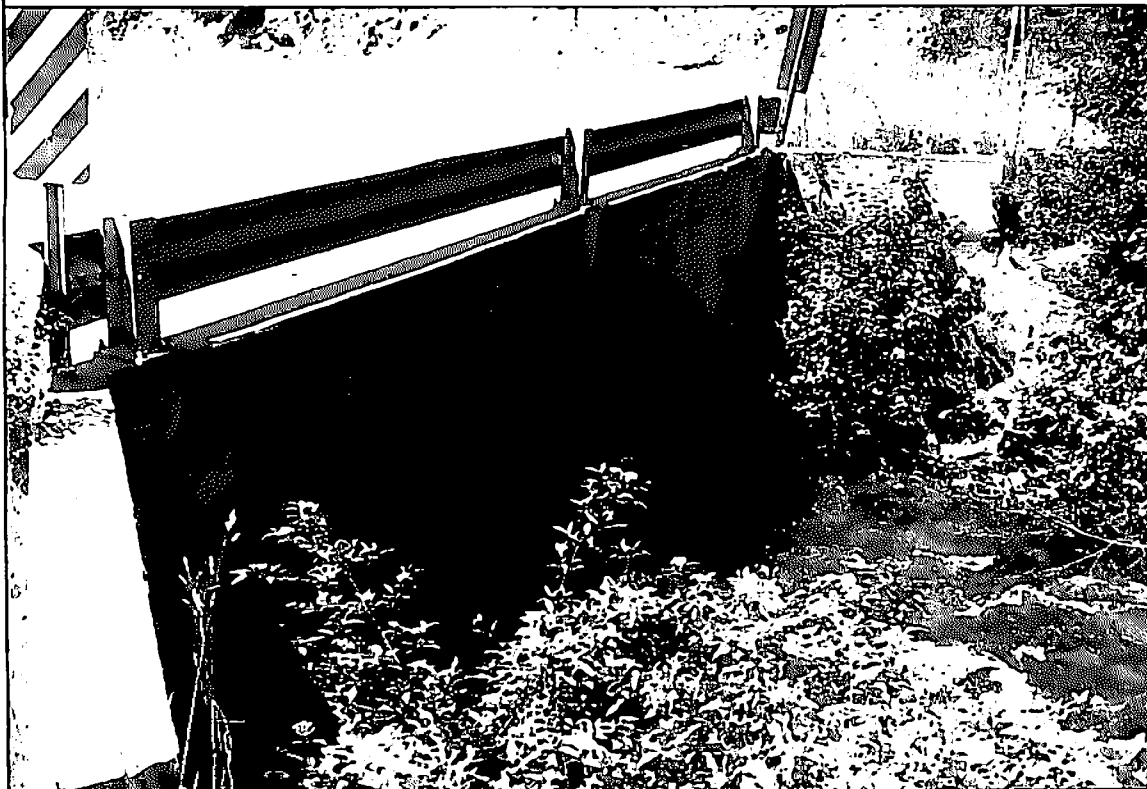
07/08/2008 - Same conditions exist, see pic..

07/19/2006 - Hazard panel at B1 Lt. is leaning out of alignment, see pic.. B2 Lt. is slightly damaged. (8.23 X 2 = 16.46)

Looking Back on Line. Downstream. ←

Note misalignment of hazard panel(s).

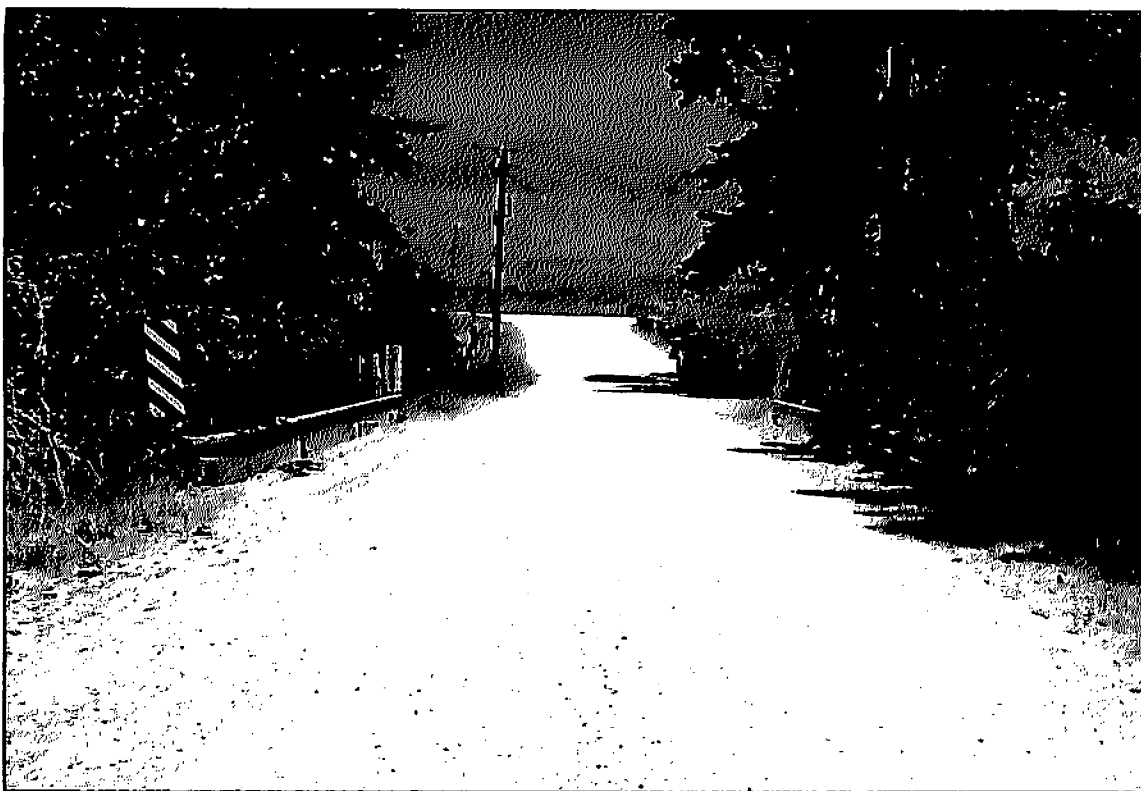
Looking Ahead on Line. Downstream. ←

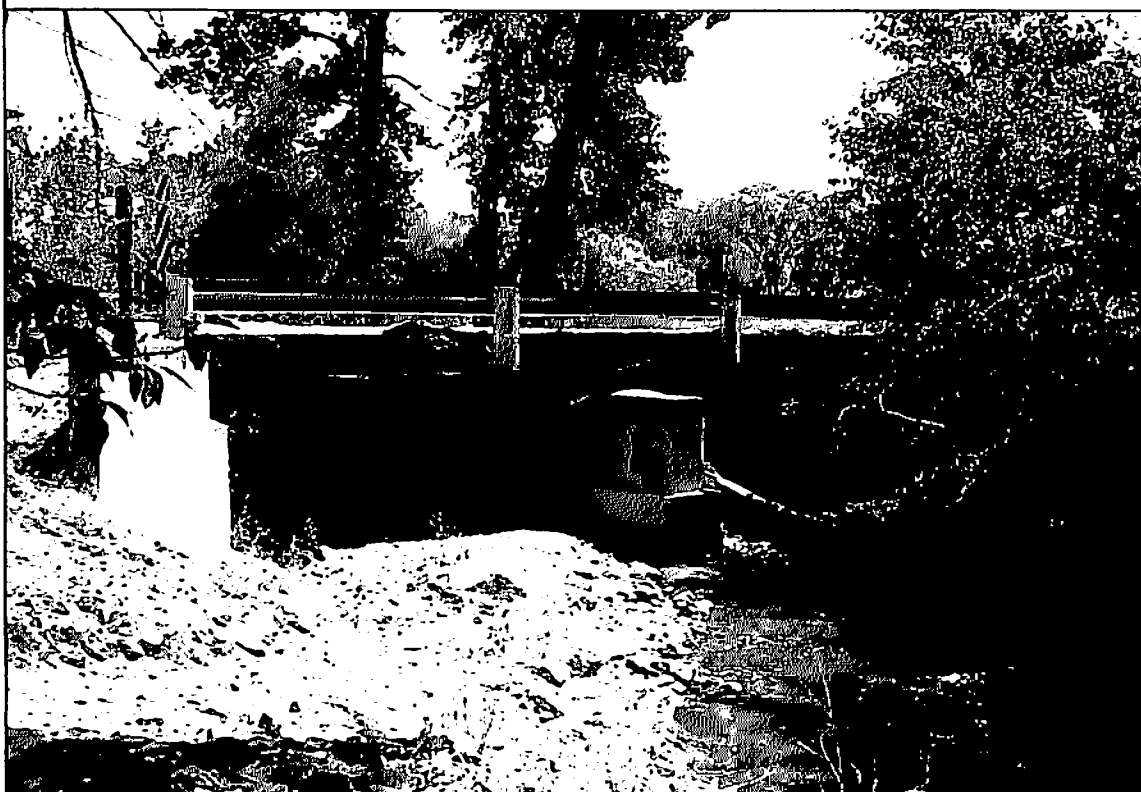
Looking Upstream. Ahead on Line. ← Note channel flow is confined to Span 1.

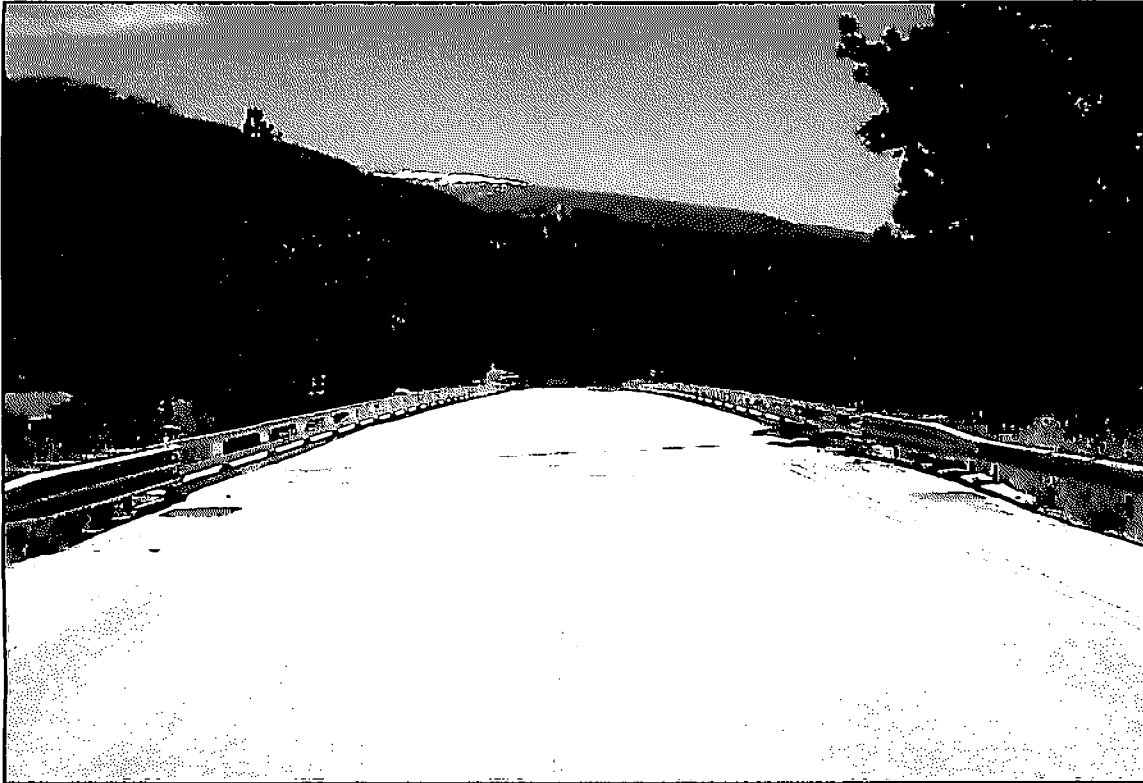
Looking Back on Line. Downstream. →

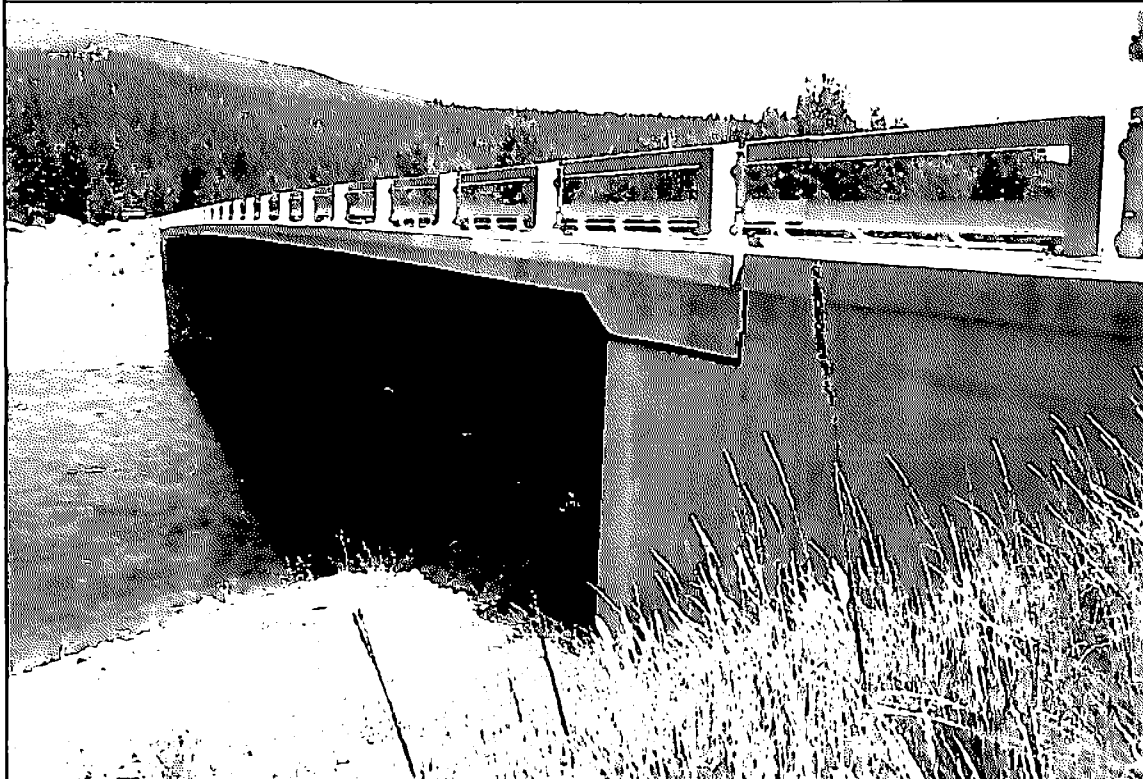
Looking Downstream. Ahead on Line. →
